Product Safety Recall

450R & 500R V8 Racing Outboard Top Cowl Bezel Assy

Models Covered	Serial Range
450R	1E083006 - 1E099696
500R	1E099432 - 1E102508

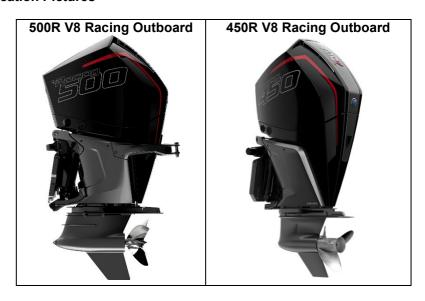
Identification Pictures

Defect: The air vents of the affected engine cover may allow for fingers to be placed through the air vent gaps.

Hazard: There is a risk of serious injury including amputation or lacerations to fingers if placed through the air vents. Injuries have occurred because of this hazard.

- 1. Consumers with affected products should contact their Mercury dealer to arrange for a bezel assembly to be installed over the air vents.
- 2. Send us an email or phone us if you are unable to return the product or have sold or gifted it to another person
